Manhole Inspection Summary

Manhole # S05CC2012MH

Insp Date: **8/7/06 1:39 PM**

Location Address: **6014 WOODCREST AVE**

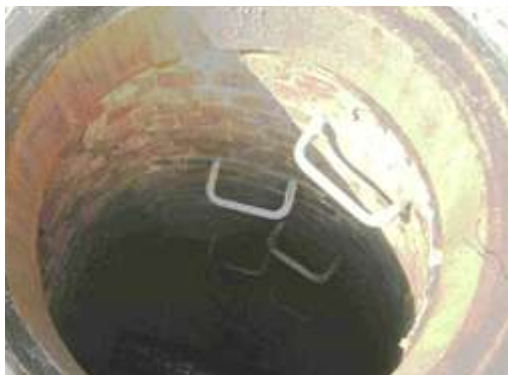
Defect

Adjustment infiltration. Bench debris.

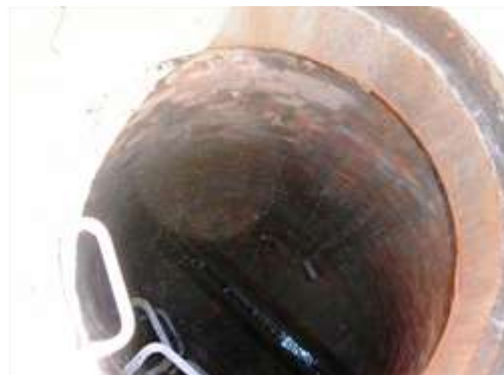
Defect

Frame leaks. Adjustment and Corbel infiltration - other side.

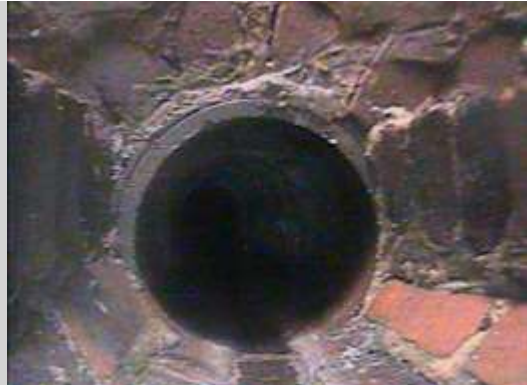
8 in. Circular Gravity Sewer Pipe Out @ 12 O'Clock

Infiltration: **Evidence** Pipe Seal Cond: **Unknown**

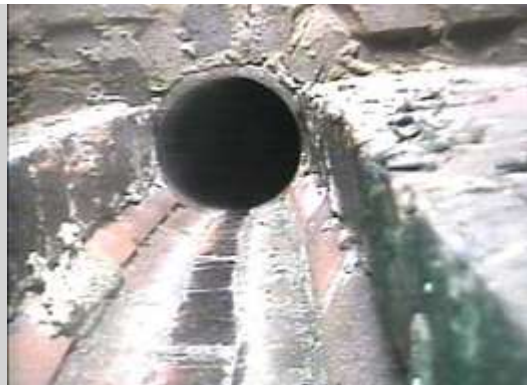
8 in. Circular Gravity Sewer Pipe In @ 6 O'Clock

Infiltration: **Evidence** Pipe Seal Cond: **Unknown**
